HORSEHAY POOL MANAGEMENT PLAN DRAFT: INTERIM REPORT

Red Kite Network Ltd
April 2020

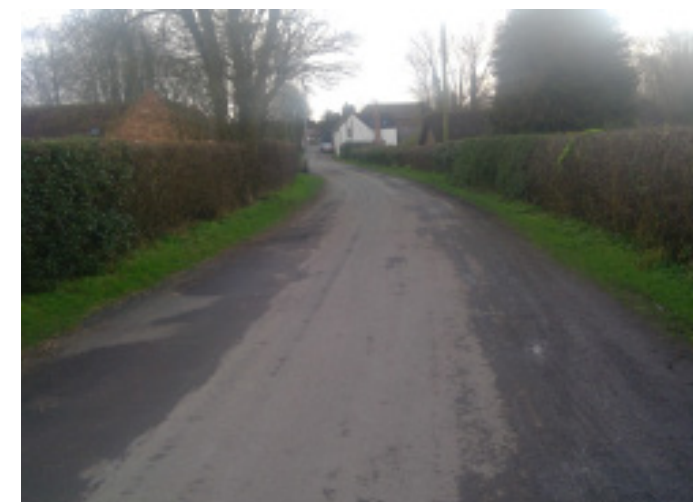
Section of unadopted highway

The latest highway condition survey revealed that this section has been assessed as Grade 5, which is the worst possible condition grade, with several cracking and crazing defects occurring throughout, alongside the large volume of potholes across the area. In 2016, a Ward Member requested cost estimates to repair the section of the road. Micro-surfacing overlay was priced at approximately £9,000 and tarmac overlay £15-20,000.

As the road is unadopted, TWC’s Highways are unable to fund these repairs, so alternative funding is required. Local Ward Members have contributed £2,000, and Rights of Way funding could contribute an additional £3,000. Dawley Hamlets Parish Council have not committed any funds out of concerns that it would encourage this route being used as a rat run, which would be especially dangerous past the children’s play area. If speed cushions were included in the scheme, it would add further costs of £2-3,000.

Local Ward Members are developing an alternative plan to use the £2,000 member funding to purchase bagged tarmac so residents can carry out the repairs themselves. These works would fill in all potholes and give a consistent surface throughout which would stop further degradation of the surface and give an expected lifespan of 5-10 years. A potential side effect of this treatment could be surface water ponding as there is not adequate drainage on site. If these repair works were undertaken, there would not be a commitment from TWC to maintain to an adoptable standard or to adopt this road due to other statutory requirements for adopted roads such as drainage and street lighting. Consequently, it would be preferable if additional funding could be found to carry out the full maintenance works and allow for potential TWC adoption in the future.

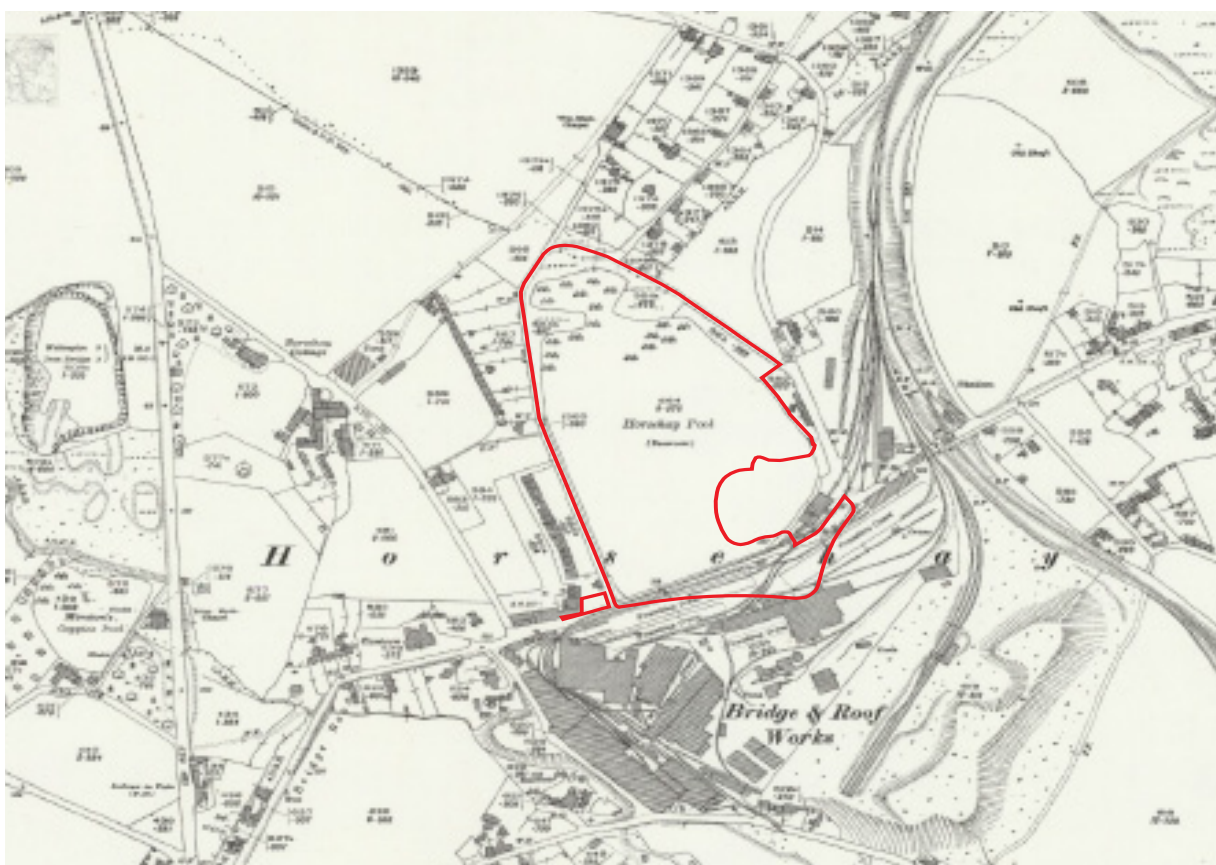
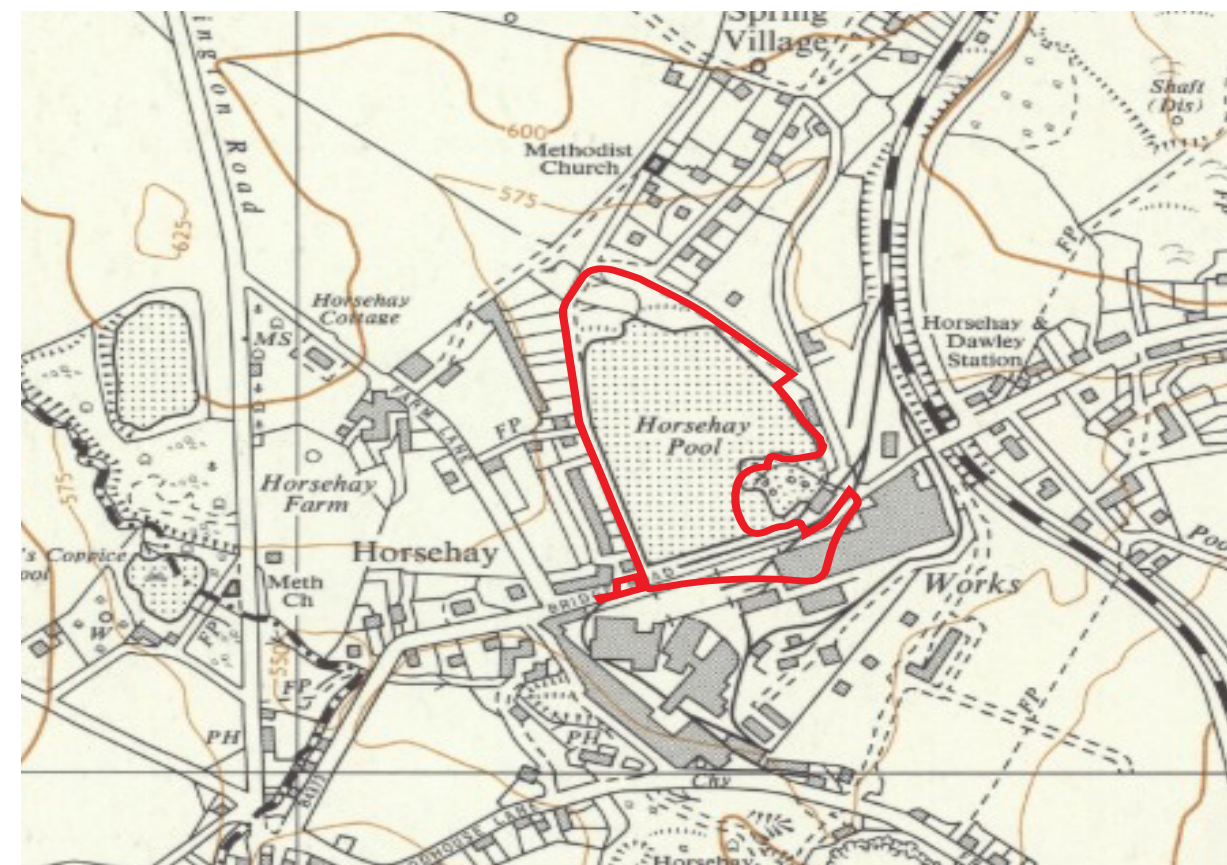
The historic maps found from 1885, 1902, 1925 and 1966 show that little change has occurred within the Site boundary and its immediate landscape context. The most significant change is the expansion of Bridge & Roof Works southwest of the Site between 1902 and 1925. The villages of Horsehay and Dawley see little development or expansion.

The extent of the pool reduces over time. The 1925 map shows the gradual contraction of the northern area of the pool. By 1966, the pool has approximately the same boundary as it has today, including the two inlet streams from the north. The 1966 map also shows the island area in the south east corner of the pool, now owned by the Telford Steam Railway Trust.

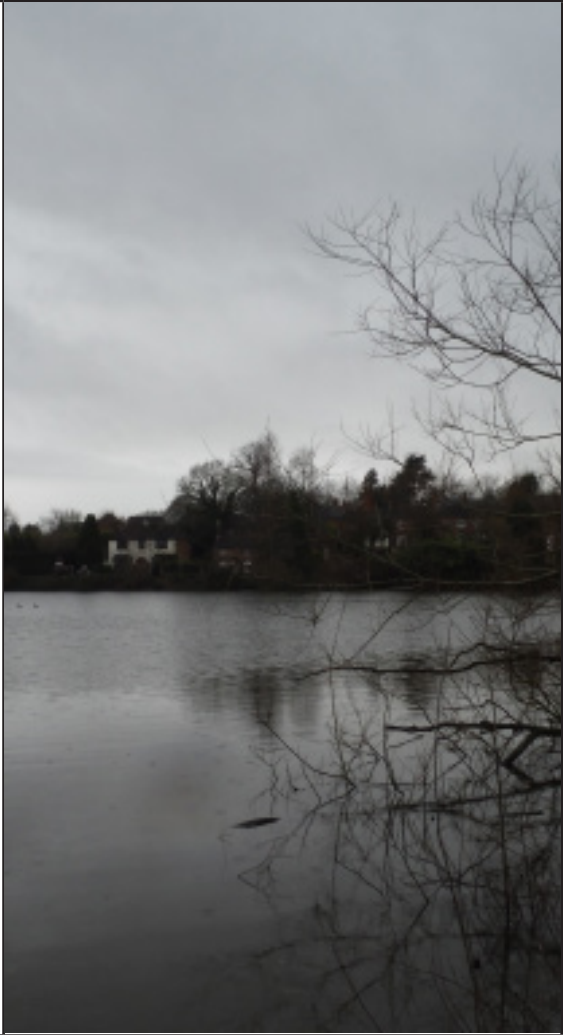
Standing Water	<p>The majority of the Site consists a single large body of open water known as Horsehay Pool. The pond does not appear to have any aquatic or emergent vegetation and it is stocked with a range of coarse fish species. The pool is fed by two inflows at the most northern part of the Site, a single large outflow is located in the southwest corner of the Site. A number of waterfowl species were observed during the walkover, including;</p> <ul style="list-style-type: none">- Mallard (Anas platyrhynchos)- Canada geese (Branta canadensis)- Moorhen (Gallinula chloropus)- Coot (Fulica atra)- Tufted duck (Aythya fuligula)- Goosander (Mergus merganser) <p>The pool is known to support the following coarse fish species;</p> <ul style="list-style-type: none">- Carp (Cyprinus carpio)- Bream (Abramis brama)- Tench (Tinca tinca)- Roach (Rutilus rutilus)- Perch (Perca fluviatilis)- Pike (Essox lucius)

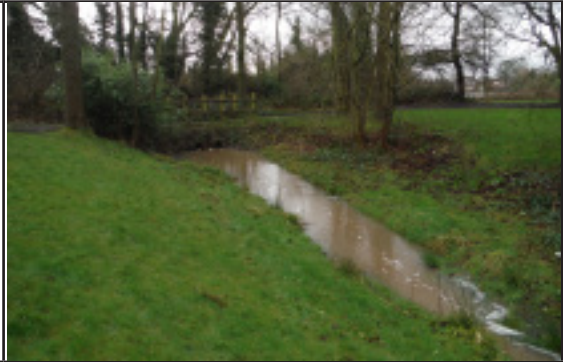
Running Water	<p>Two water inlets enter the Site from under the road to the north. During the survey the water flow was heavy due to recent heavy rainfall. The stream runs directly into Horsehay Pool. No aquatic vegetation was noted during the survey but this maybe the result of an increased water level. Soft rush (Juncus effusus) was present along the margins.</p>

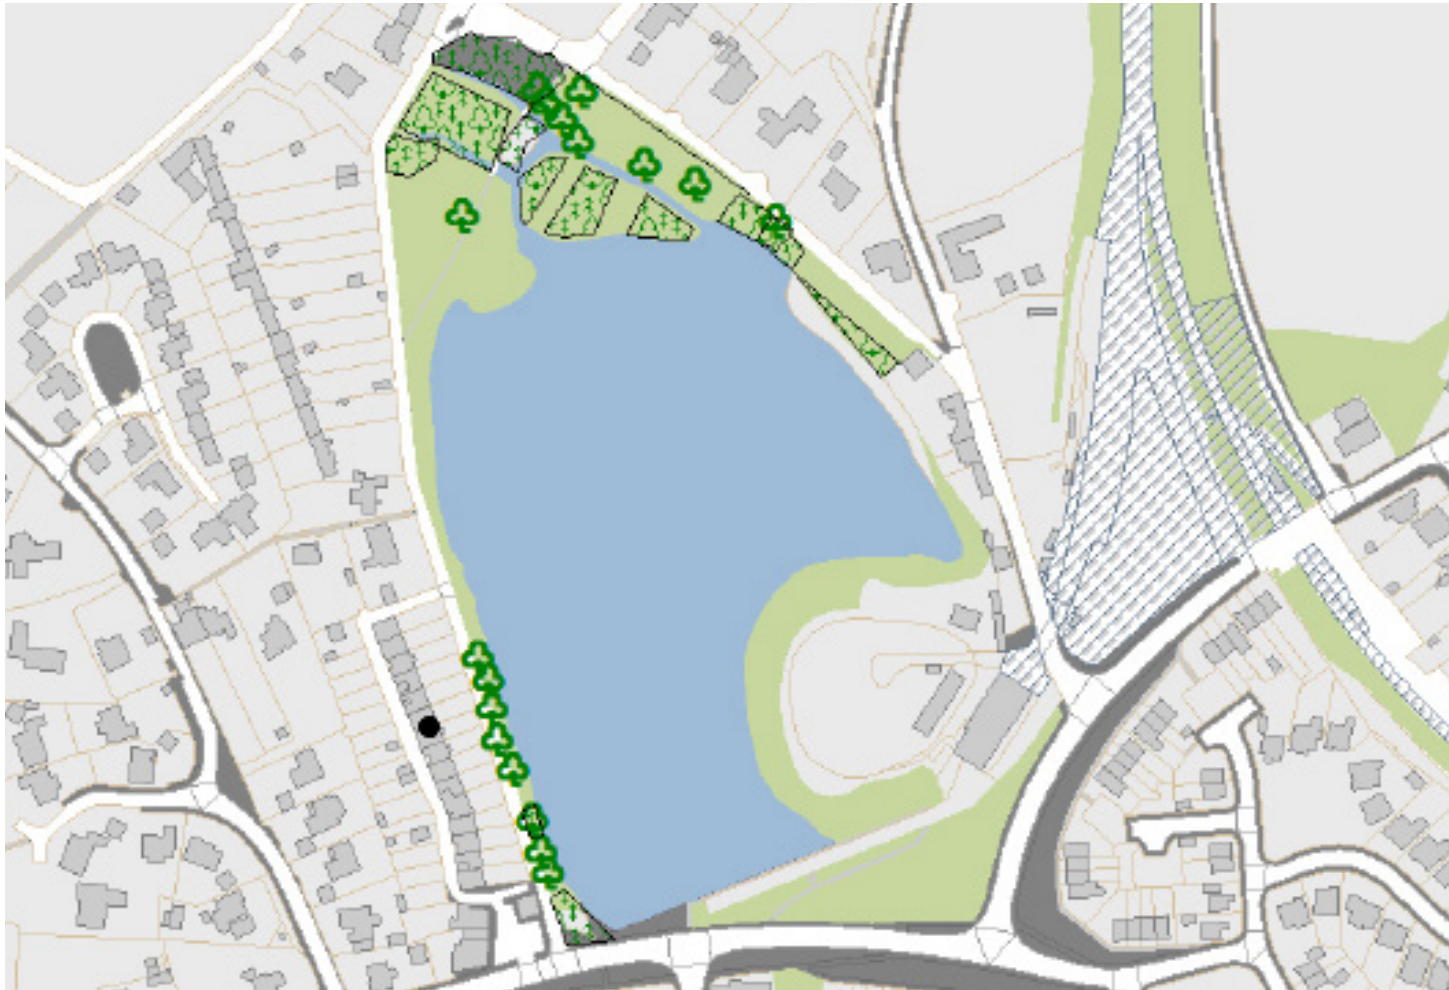
Locations of individual trees and groups of trees used for regular tree surveys

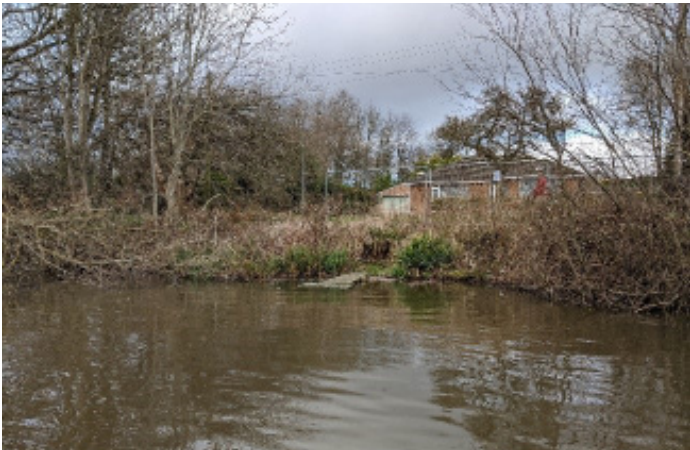
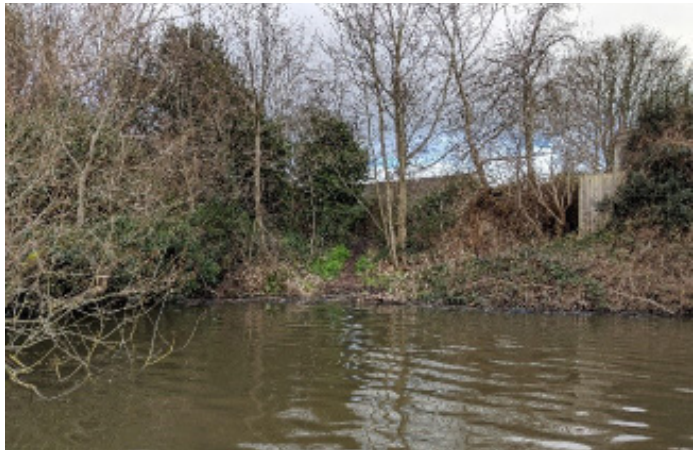
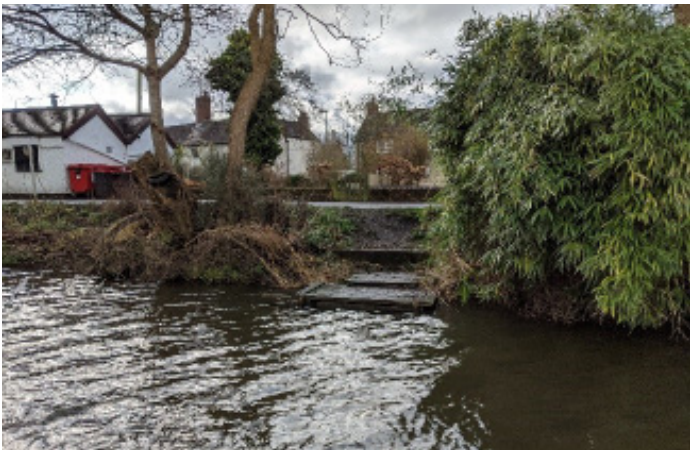
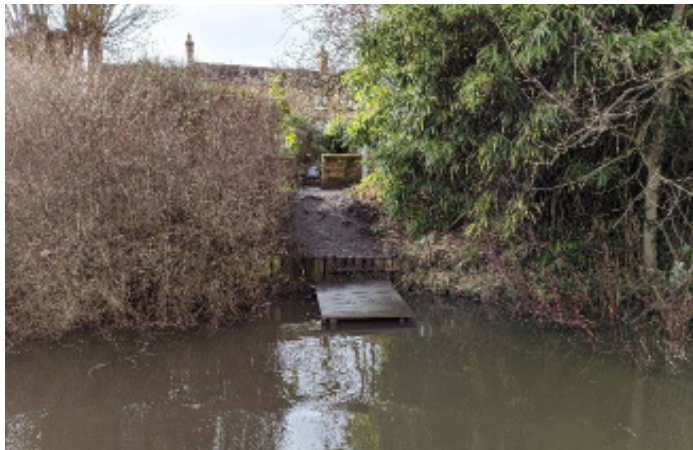
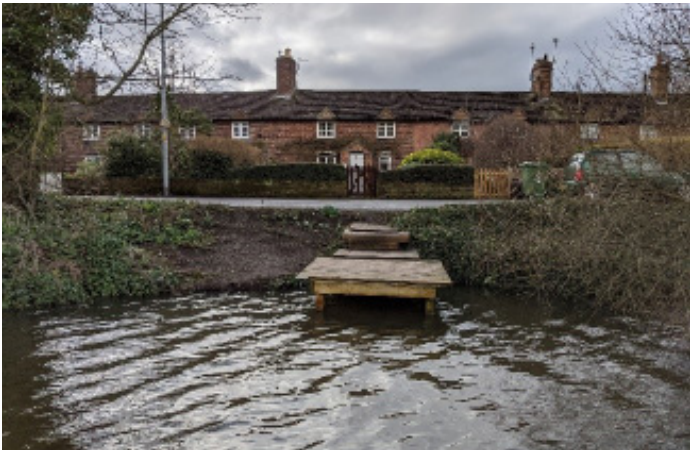
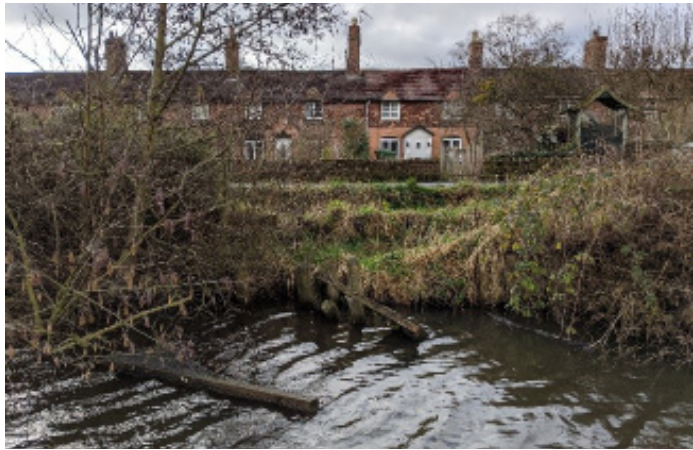
Fishing platforms vary in design and construction, with several being in a state of disrepair, potentially posing health and safety issues to anglers and the general public. There is no evidence of provisions being made for disabled users to access and fish the pool, which is recommended under the Equality Act 2010. The following recommendations are provided:

Fishing peg on eastern bank

Fishing peg on western bank

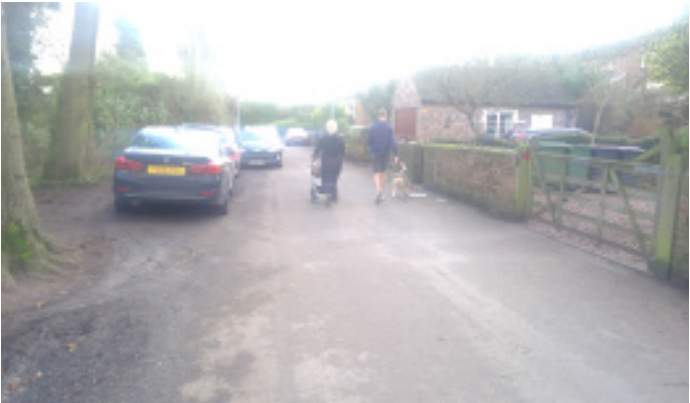
No separation of vehicles and pedestrians

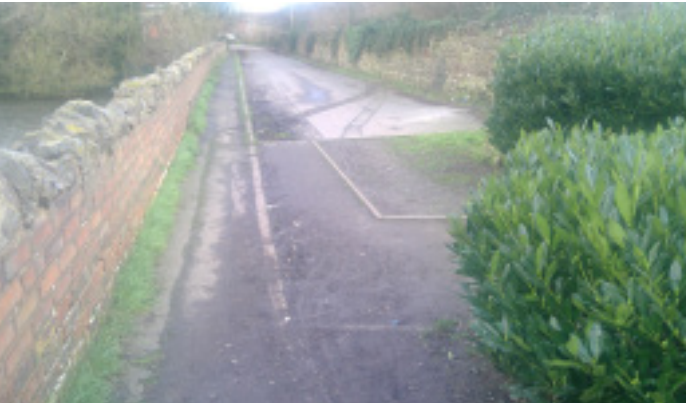
Narrow and illegible path network

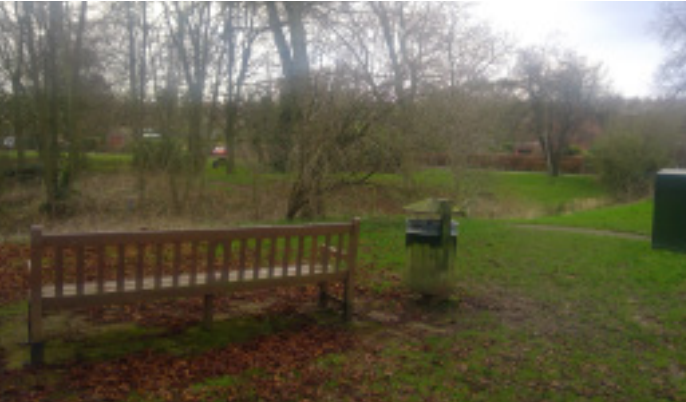
Lack of surfacing to seating areas

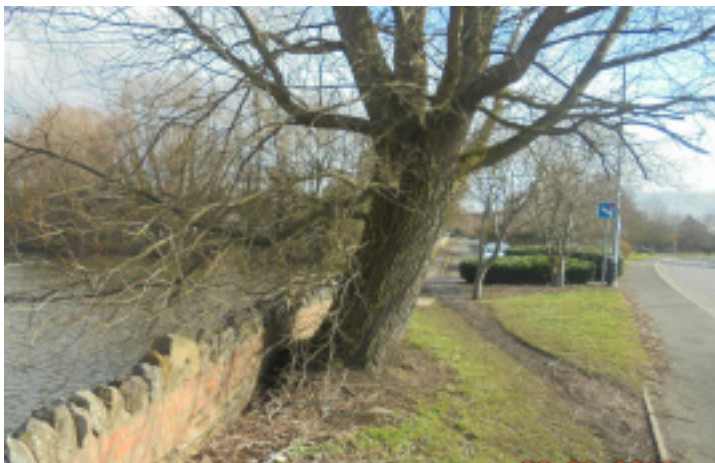
Tree that was removed on west end of wall

The ten year report (Stillwater Associates Ltd, September 2016) of the Horsehay Pool Reservoir, as required by Section 10 of the Reservoirs Act 1975, contains a number of recommendations. Firstly, it recommends repairs are carried out to the brick wave wall to prevent further damage, including spalling, loss of individual bricks and cracking, as necessary. In addition, any debris should be removed from the grille over the weir weekly. The report also noted a large tree which was growing near the west end of the dam wall and causing it to bulge towards the reservoir. This tree failed in a storm and caused the dam wall to be breached, leading to repair works beings carried out in 2019. The report also recommends further surveys and studies to be undertaken at the Site, including:

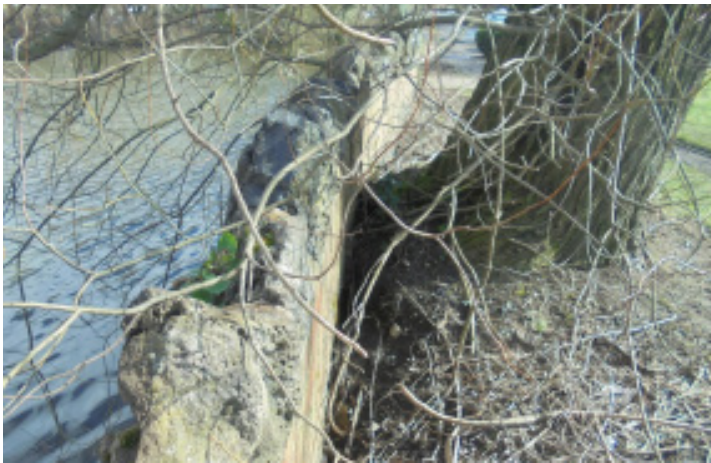
Bulging caused by tree, which was later removed

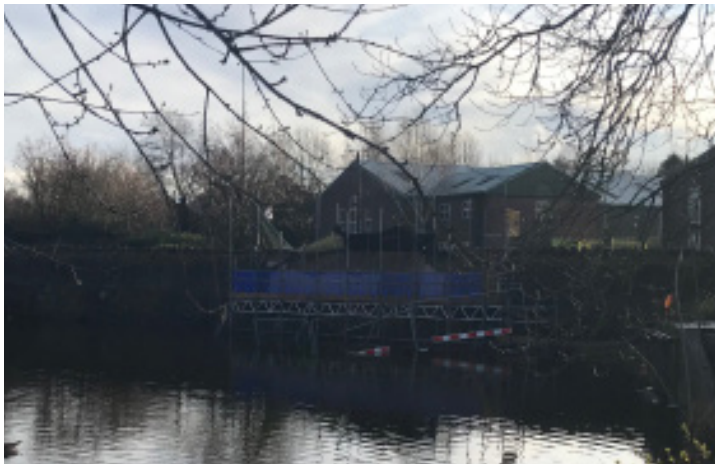
Wall repair works being undertaken 2019-20

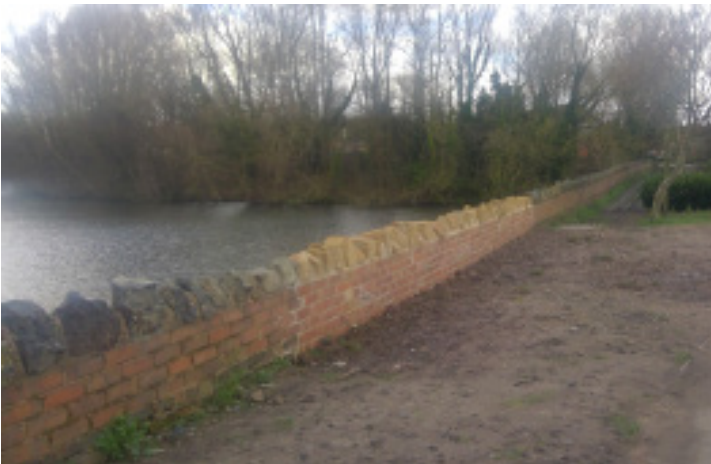
Completed section of repaired wall

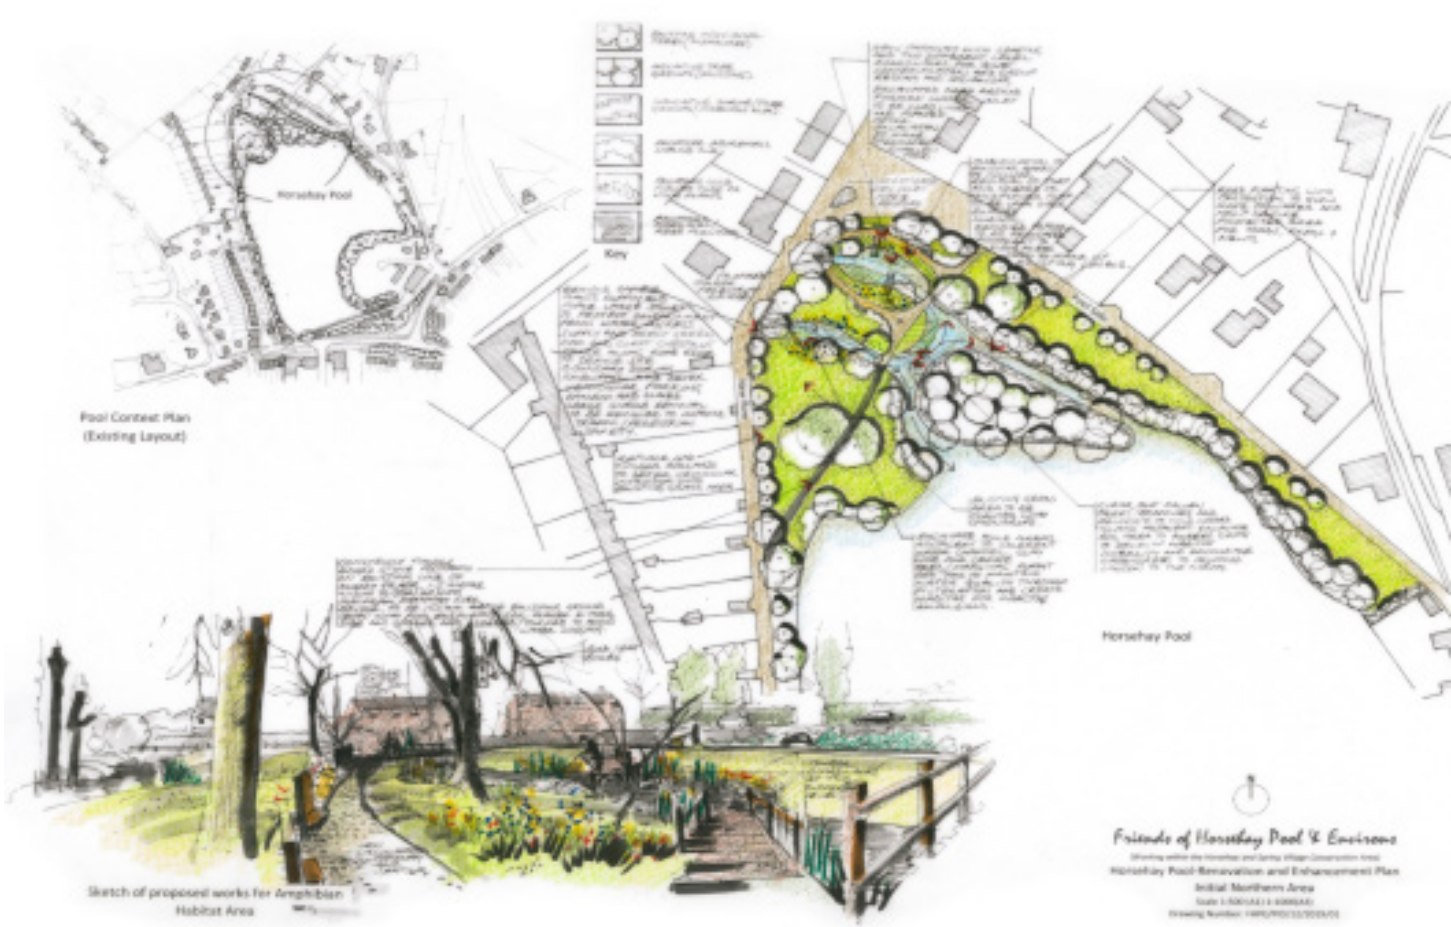
Pocket Parks proposal, Friends of Horsehay Pool and Environs

Group drew up plans for the north of the Site to inform an application to the Pocket Parks scheme. Their grant application was successful, and they have a total of £21,500 secured for the project (including £4,500 donation from Dawley Hamlets Parish Council). The project was to take place between March and July 2020, but this has been delayed due to the outbreak of Covid-19. The proposals include the following features:

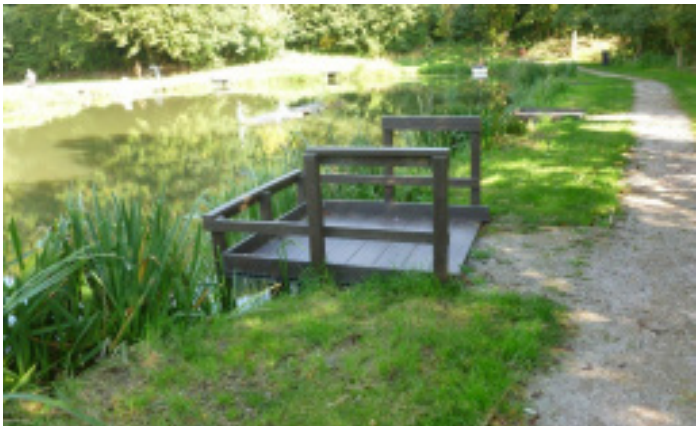
Wheelchair accessible fishing pegs

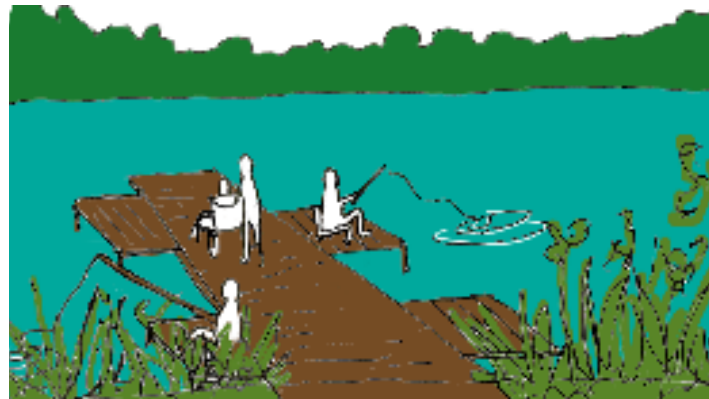
Sketch perspective view of fishing pontoon to replace existing fishing pegs, providing all-access angling opportunities.

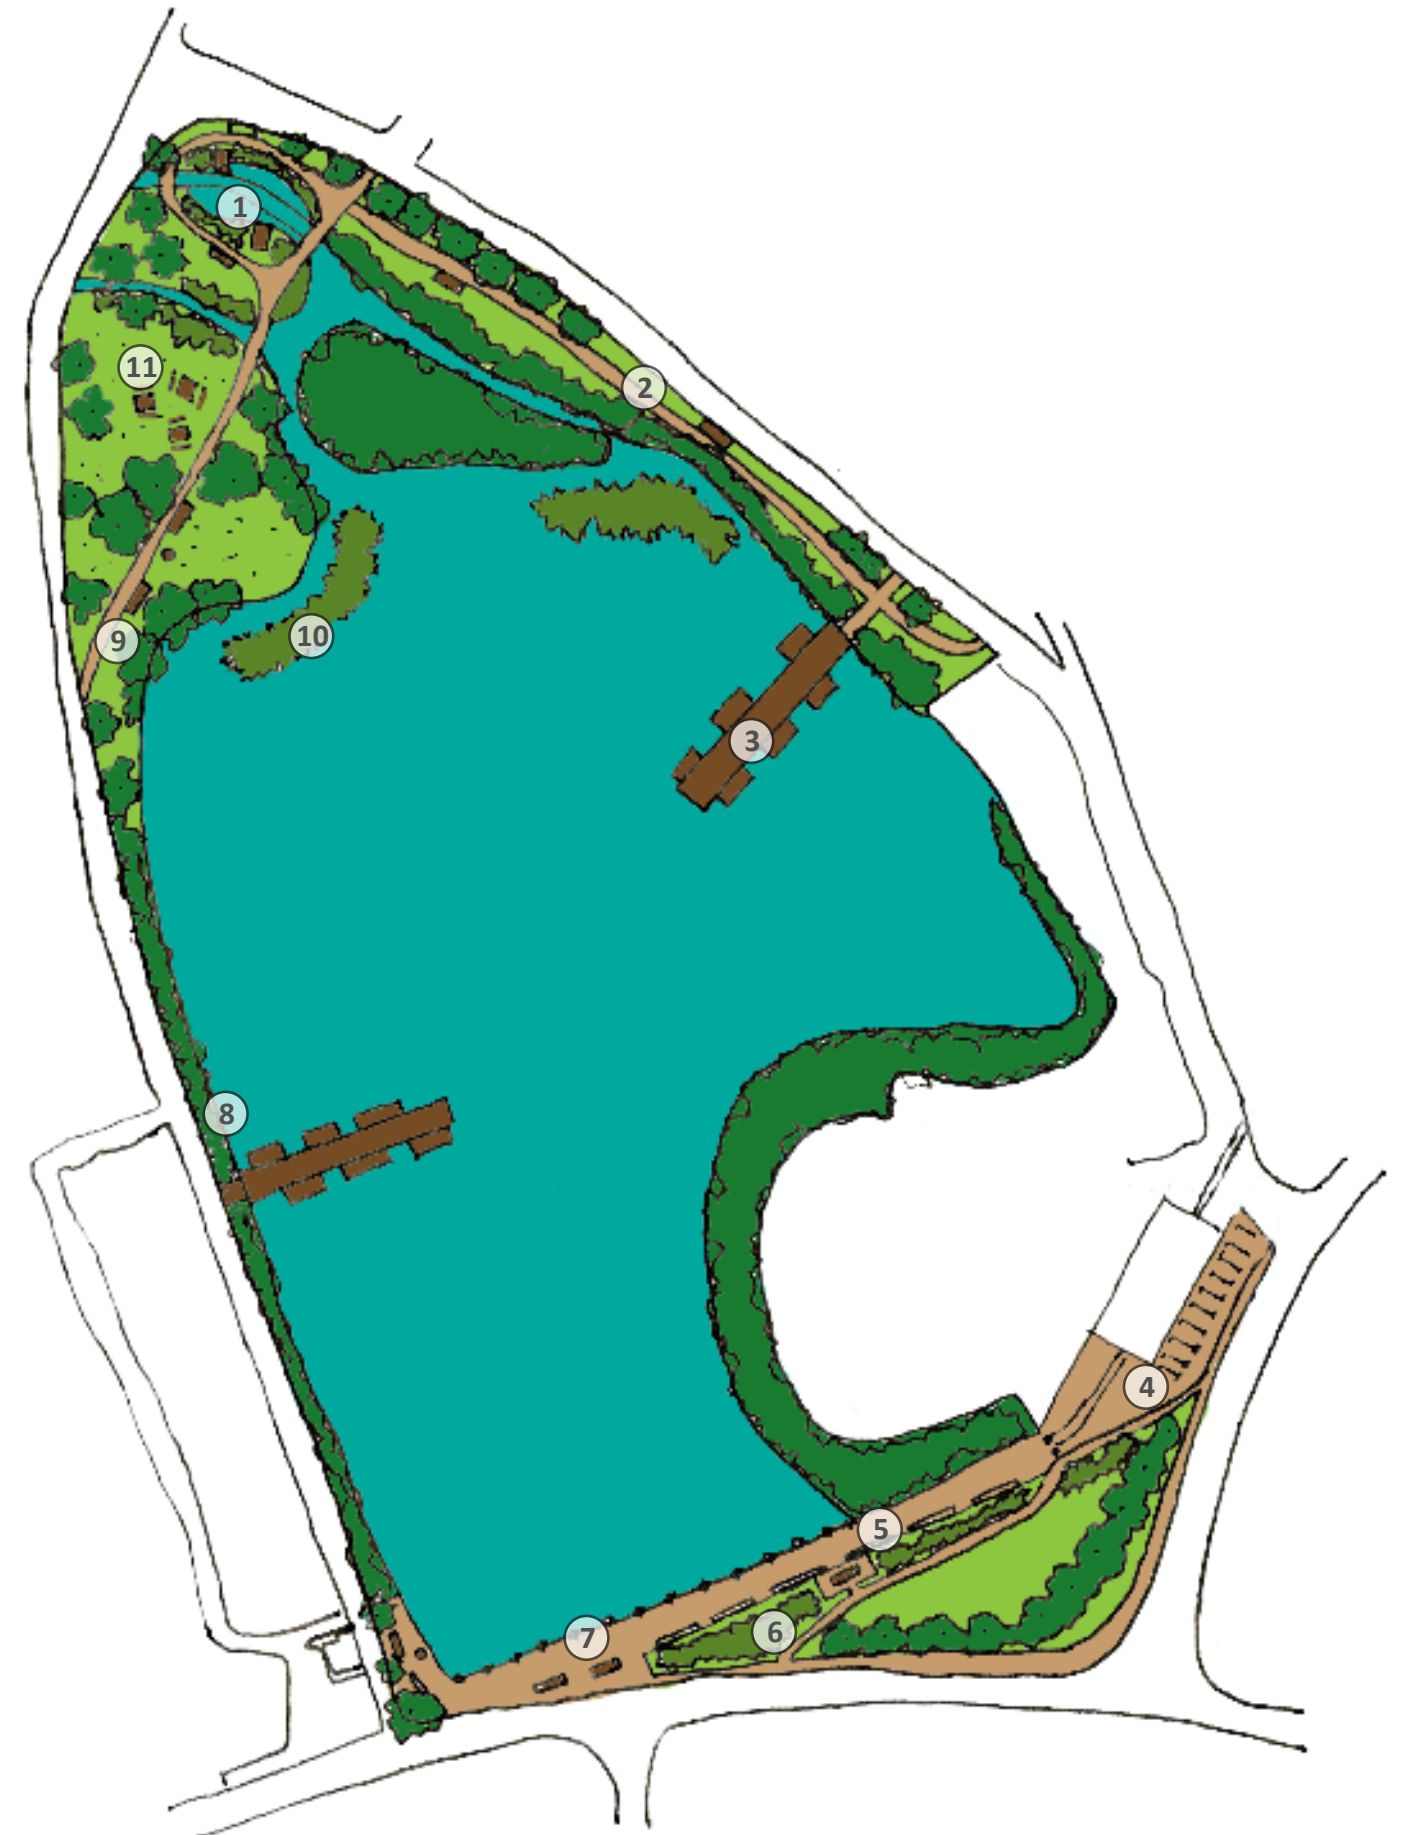
Sketch Option 2 Plan

3. All-access fishing pontoon to replace existing fishing pegs.
4. Resurfacing of old Bridge Road and reinstatement of former train lines to Old Loco Shed. Provision of formalised car parking spaces, and bollards to prevent vehicular access along pedestrianised old Bridge Road.

7. Post and rail fencing to replace dam wall and offer uninterrupted views across the pool. Gateway area on the corner of Bridge Road and Pool View enhanced with resurfacing and seating.

8. Bankside vegetation managed, with phased removal of non-native planting and dead, diseased and damaged trees, and replacement with native shrubs and trees.

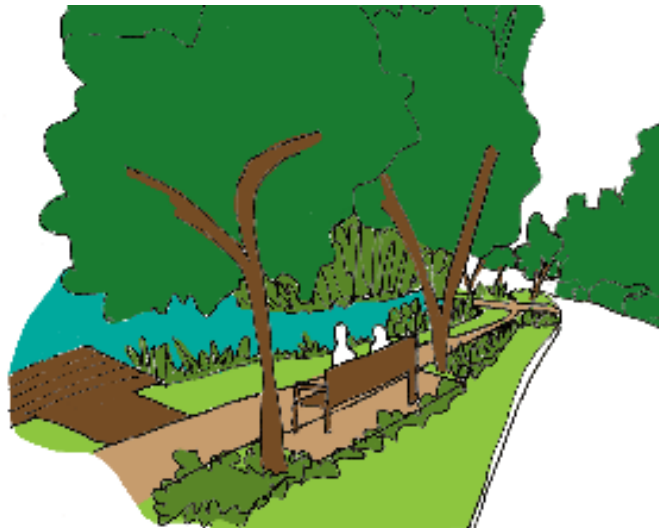
Sketch perspective view showing Pool Side, with new all-access fishing pegs, surfaced path network and seating set within planting beds.

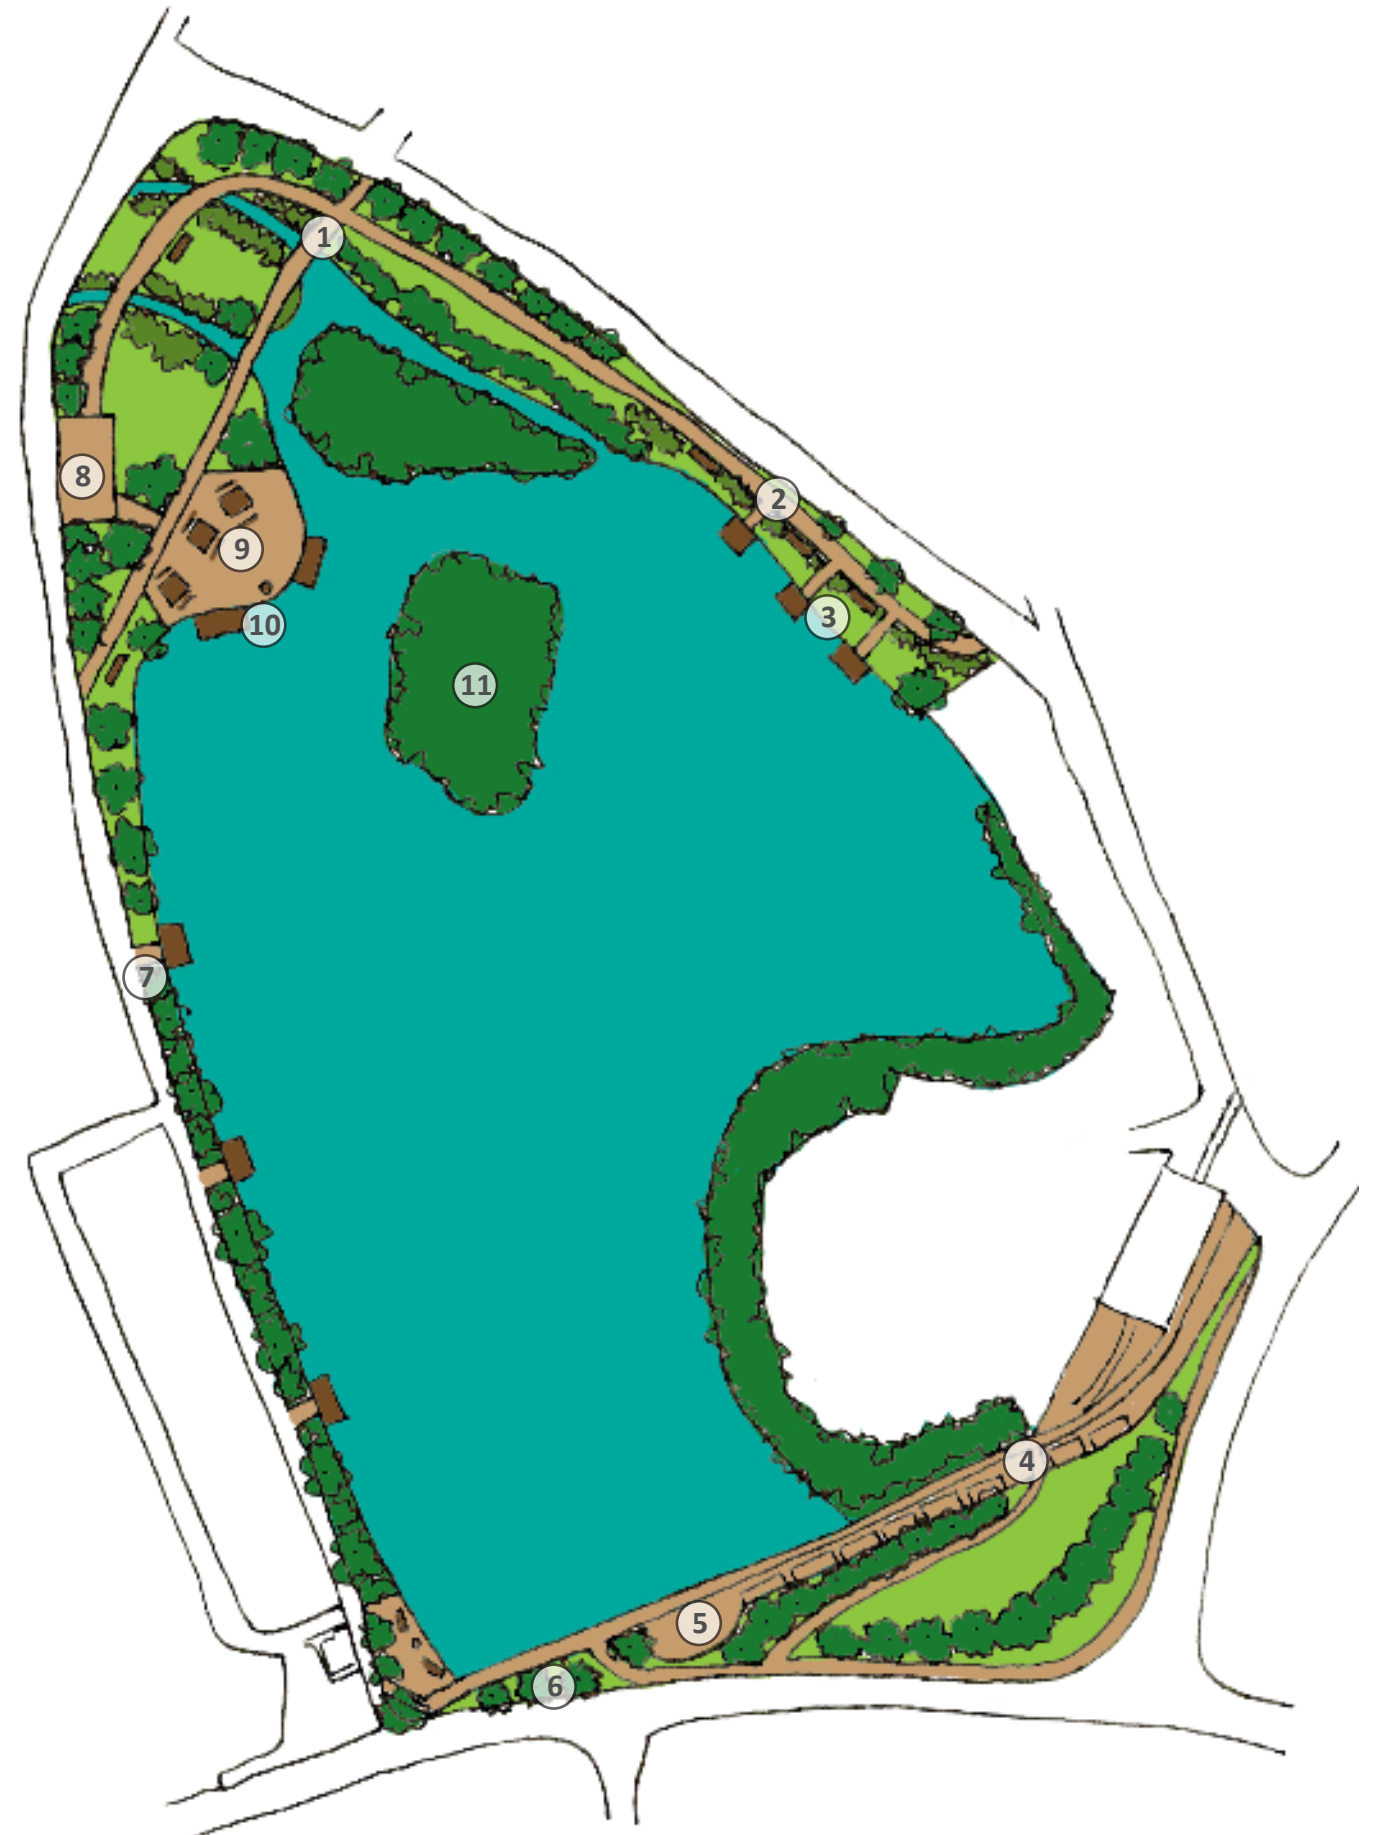
Sketch Option 3 Plan

5. Hammerhead turning circle for cars.
6. Entrance area off Bridge Road enhanced with new landscaping.
7. Existing fishing pegs (up to 3no.) renovated and access formalised. Bankside vegetation managed, with phased removal of non-native planting and dead, diseased and damaged trees, and replacement with native shrubs and trees.
